2023 VOLUNTEER LAKE ASSESSMENT PROGRAM INDIVIDUAL LAKE REPORTS

DEERING LAKE, DEERING

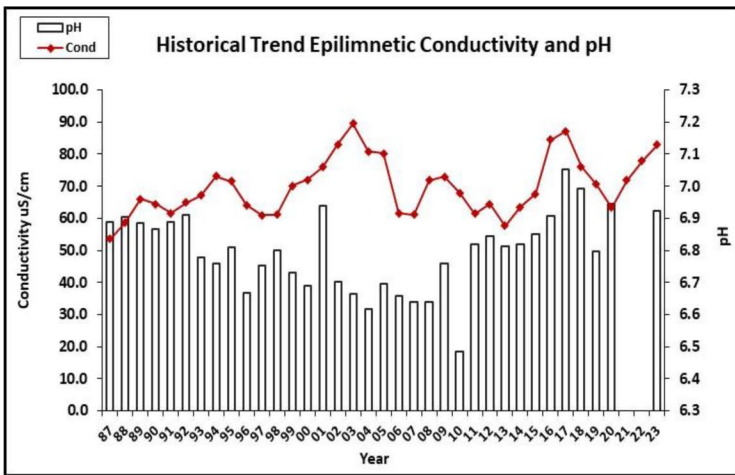
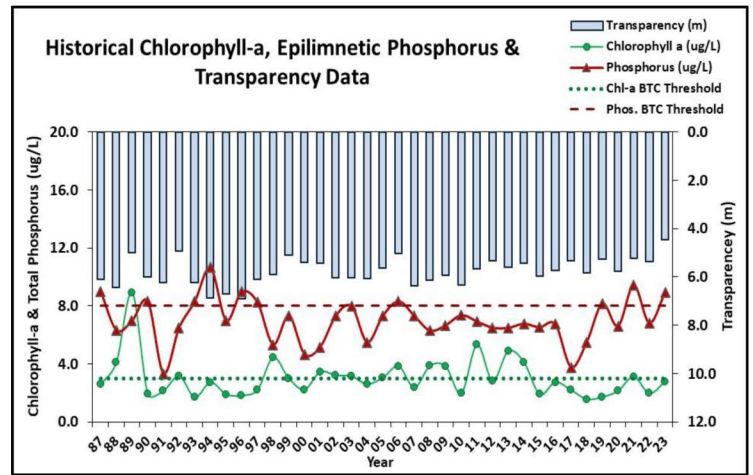
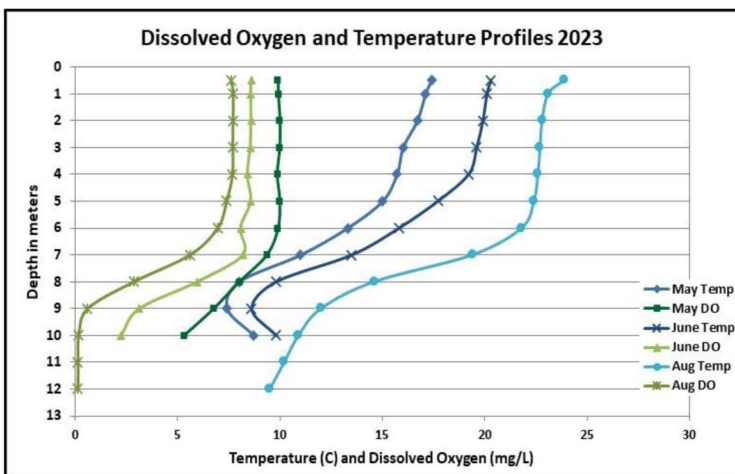
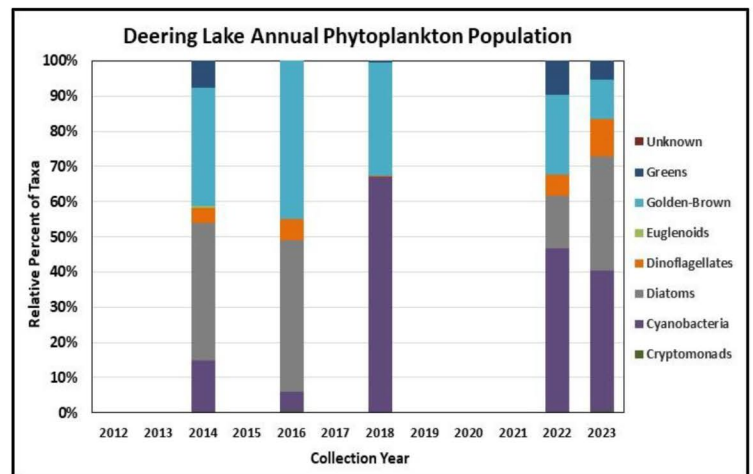
HISTORICAL WATER QUALITY GRAPHICS

PARAMETER	TREND	PARAMETER	TREND
Conductivity	Worsening	Chlorophyll-a	Stable
pH (epilimnion)	Stable	Transparency	Worsening
Phosphorus (hypolimnion)	Improving	Phosphorus (epilimnion)	Stable

Recommended Actions: Great job sampling in 2023! Lake phosphorus levels increased in 2023 and water clarity was poor likely due to the excessive summer rainfall amounts, similar to that experienced in 2021. This highlights the importance of managing stormwater runoff from lake and watershed properties. Great job collecting monthly dissolved oxygen and temperature profiles! Phytoplankton data suggest [Cyanobacteria](#) are becoming more dominant in the lake and highlights the importance of minimizing nutrient (phosphorus) loading from the watershed. Keep an eye on the lake for any signs of Cyanobacteria blooms or surface scums and alert NHDES' [Harmful Algal Bloom Program](#). Campbell Cove Inlet experienced elevated phosphorus levels following a storm event in August. Continue monitoring this new location and monitor any logging activities in the sub-watershed for areas of stormwater runoff and erosion. Encourage winter maintenance companies to obtain NH Salt Applicator License through the [Green SnowPro Certification](#) Program. Encourage the town to conduct spring cleaning of roadside ditches and catch-basins to remove sand/salt that accumulated over winter. Educate shorefront property owners on becoming certified [LakeSmart](#) through NH LAKES' lake-friendly living program. Watershed management efforts should focus on [managing stormwater runoff](#), [dirt/gravel road](#) stabilization, and reduced application of [road salt](#) and sand during winter months. Keep up the great work!
